SIGNIFICANT INCIDENT REPORT

Incident: 018965 - 15092020

Address: Orsted BESS, Carnegie Road, Liverpool, L137HY

Date of incident: 15th September 2020

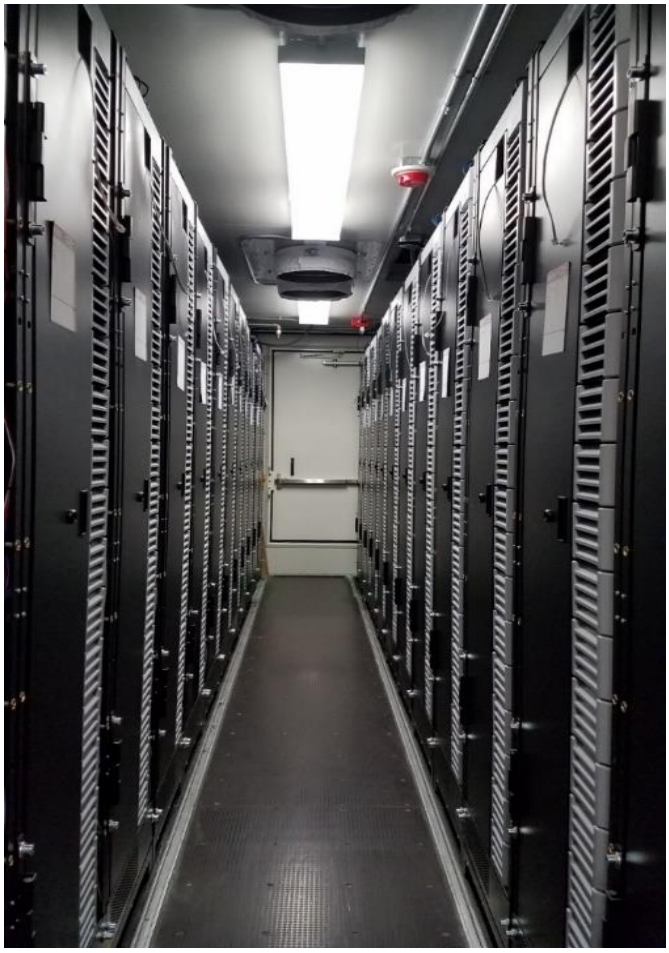
Inside a BESS Unit[2]:

Note configuration of lithium ion banks, narrow access corridor and cooling vents fitted to ceiling.
